NASA/TP-2009-214769

A Summary of NASA and USAF Hypergolic Propellant Related Spills and Fires

B. M. Nufer
Kennedy Space Center, Florida

June 2009

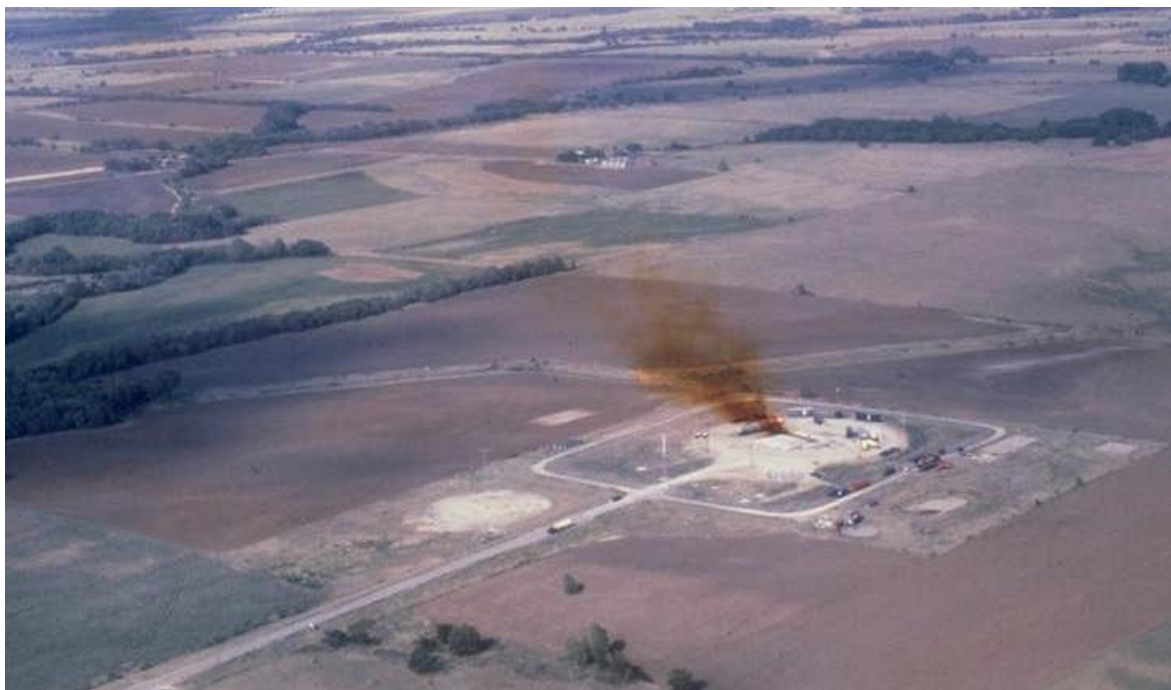
Figure 5-2: Aerial View of N₂O₄ Vapor Cloud Coming from Missile Silo 533-7

On August 24, 1978, at McConnell AFB southeast of Wichita, Kansas, the worst reported unintentional N₂O₄ spill in U.S. history took place. Approximately 13,450 gallons of liquid N₂O₄ spilled into the underground missile silo. Two members of the 381st Strategic Missile Wing were killed and 25 more were injured from N₂O₄ liquid and vapor exposure. The silo also suffered extensive damage. The Titan II first and second stages were an A-50/N₂O₄ bi-propellant propulsion system. The loading operations were completed using a holding tanker located above ground. Recall that N₂O₄ (NO₂) vapors are heavier than air and they boil at approximately 70 °F at ambient pressure.

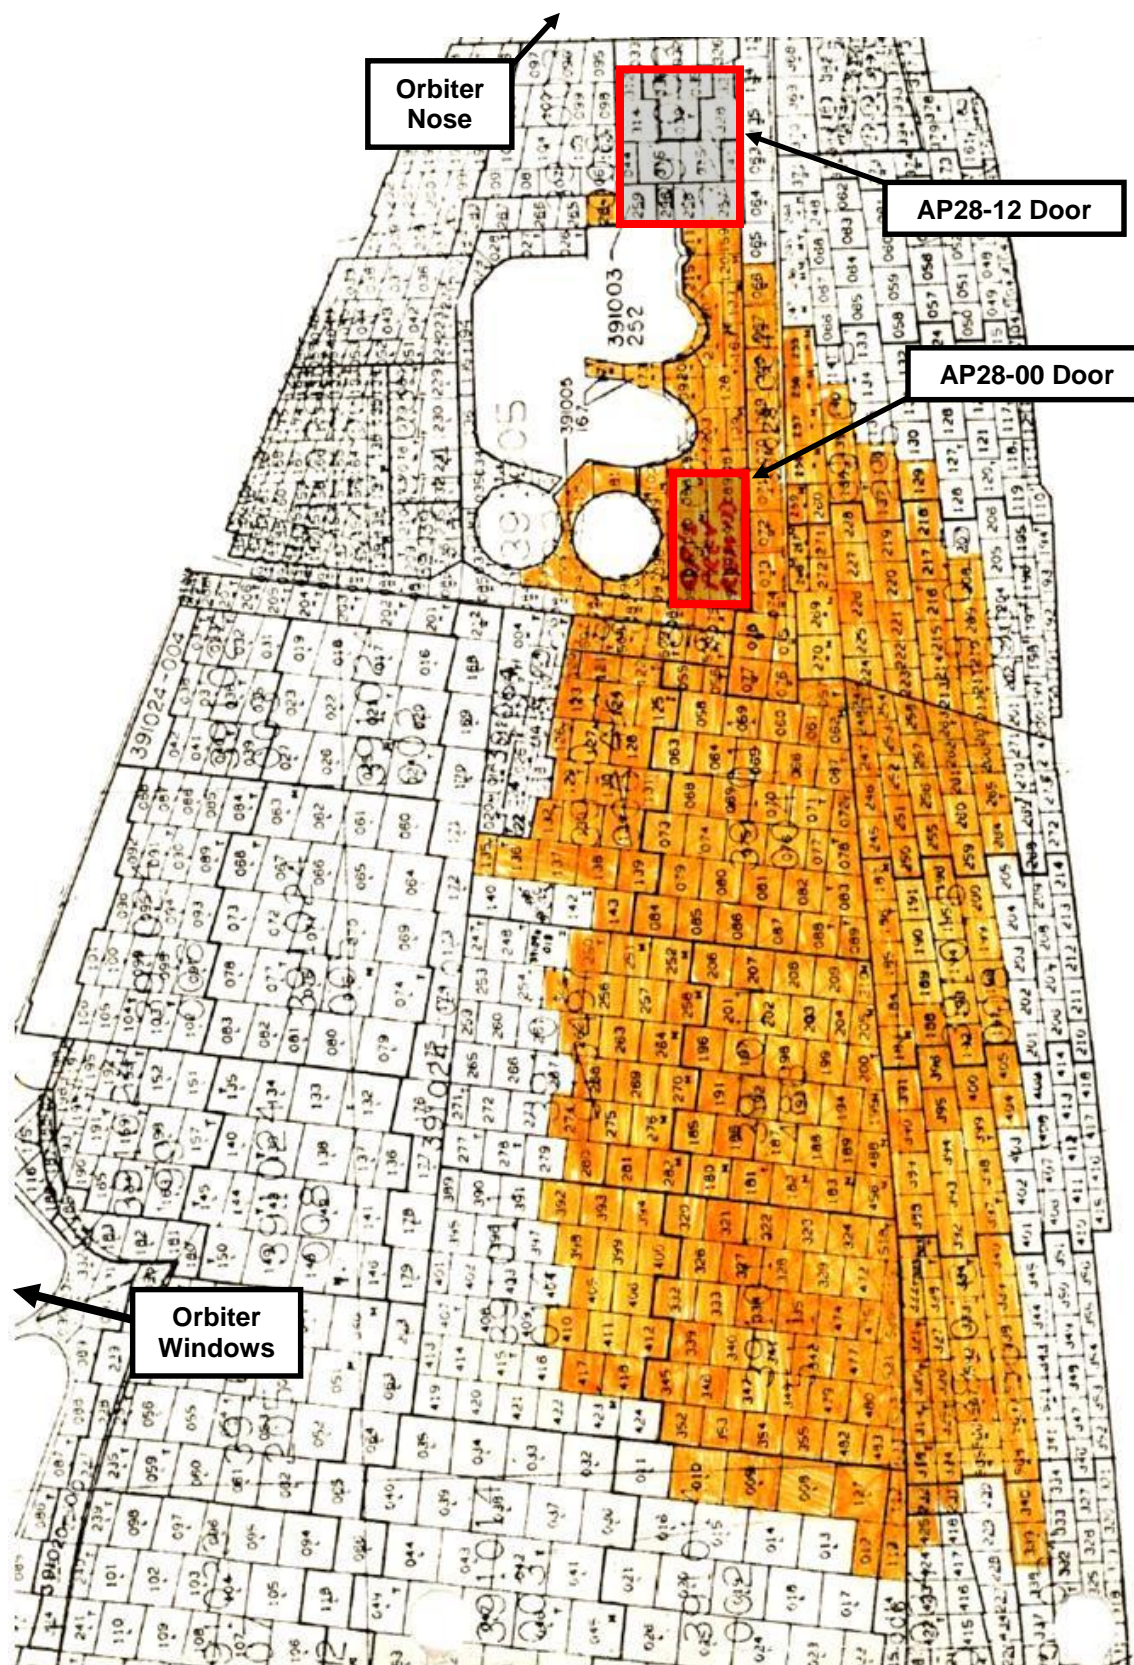
Figure 11-4: Removed Tile from OV-102 Following STS-2 N_2O_4 Spill

Corroded structural components that had been exposed to oxidizer vapors were later found in the internal portion of the FRCS module. It is believed that the vapors entered the forward module through small test ports located at the external doors. Many years later it was also found that the oxidizer vapor reacted with several electrical connector backshells within the FRCS.

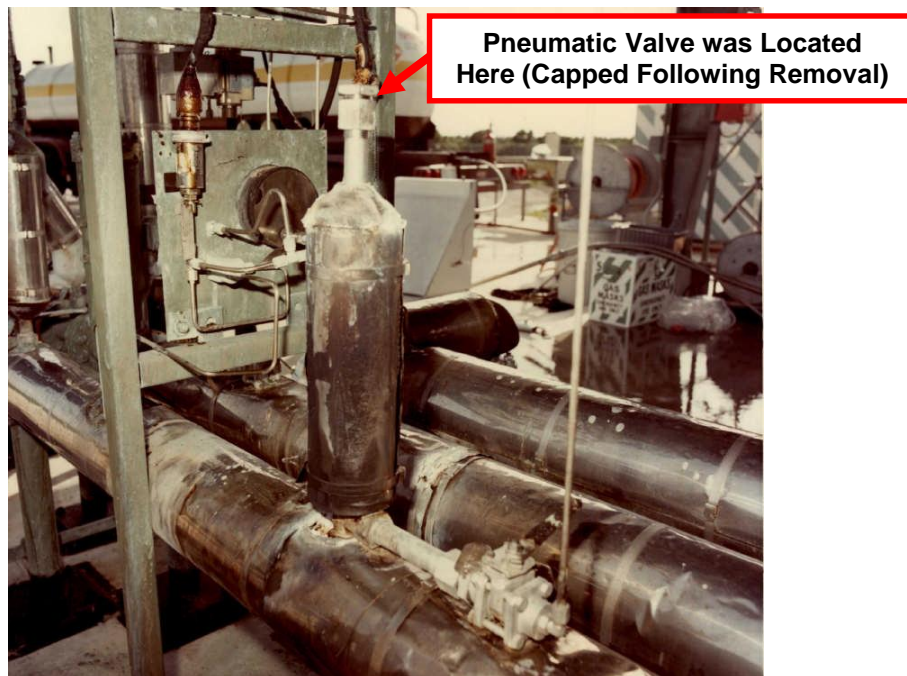
Figure 12-1: Photograph of Fuel Farm Following Fire

- The procedure was not written or reviewed by an experienced engineer prior to the task
- The engineer on console was making changes to the procedure real-time while monitoring another task in parallel
 - Improper adherence to the procedure and the procedure approval process are also root causes of this incident
- There was only one engineer on console supporting the hazardous operation
 - The engineer had to leave the communications channel to talk to the test conductor and in doing this missed some reports from the personnel at the fuel farm
- There was not a charged water line nearby when the fire occurred

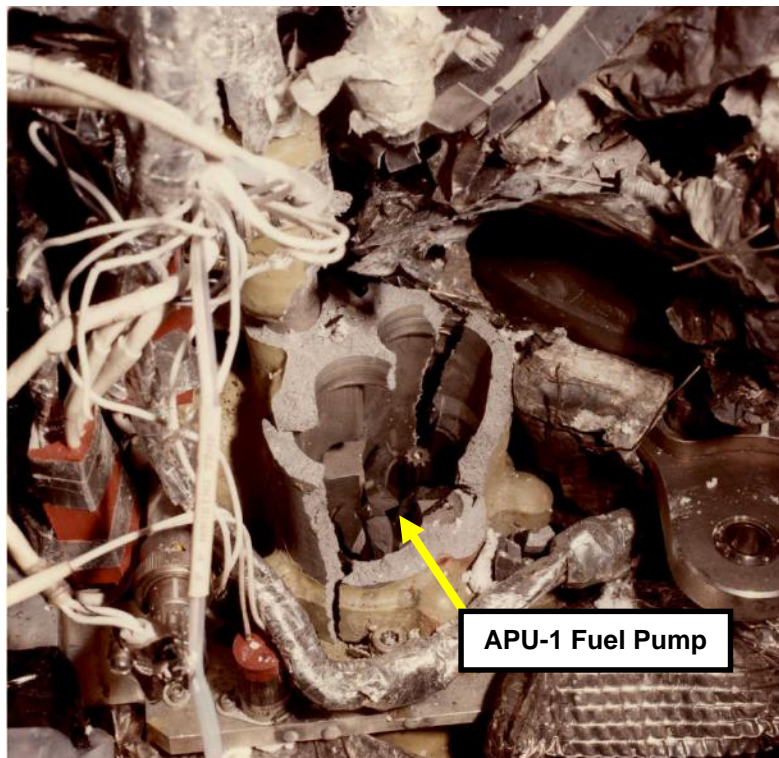
Figure 15-1: APU 1 Fuel Pump Explosion Following STS-9

The APU failures most probably resulted from a crack in the injector stem caused by corrosion of the sensitized inside diameter surface. The corrodant is probably carbazic acid or some similar substance which can be derived from air, moisture, CO₂, hydrazine and/or ammonia. The corrosion is time dependent and the crack progressed under sustained stress levels from the inner diameter surface toward the outer diameter surface until mechanical or thermal fatigue conditions could [complete] the crack rupture."

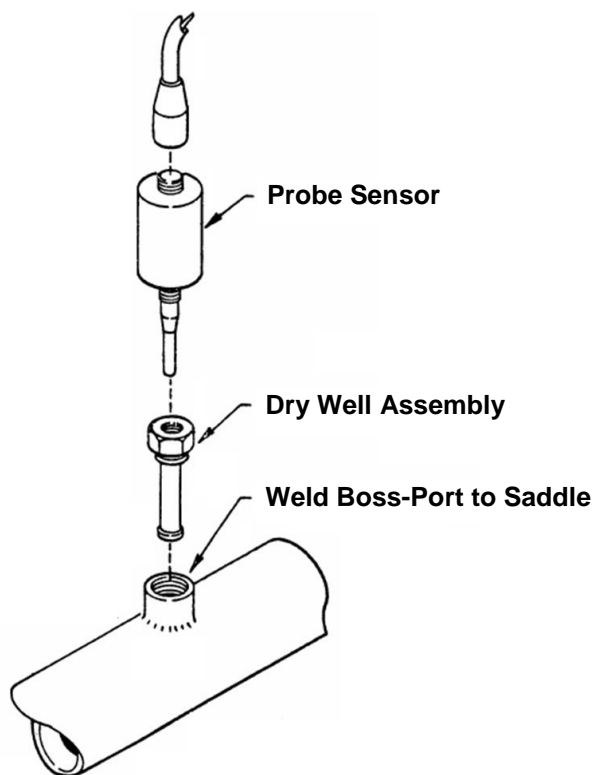
Figure 20-1: Transducer and Dry Well Assembly

"The LSOC hypergolic mechanical technician actually performing the task of transducer removal used incorrect shop practice and loosened the wrong nut. Instead of using a one-inch wrench to retain the dry well in place while loosening the transducer lock nut that threads into the dry well, he used the wrench to loosen the dry well. He then used his hand to unscrew the transducer thinking he was extracting the transducer from the dry well while he was actually unscrewing the transducer dry well assembly from the three-inch MMH line. A mixture of fluid and vapor MMH immediately erupted from the line sending a column 10 to 12 feet in the air."

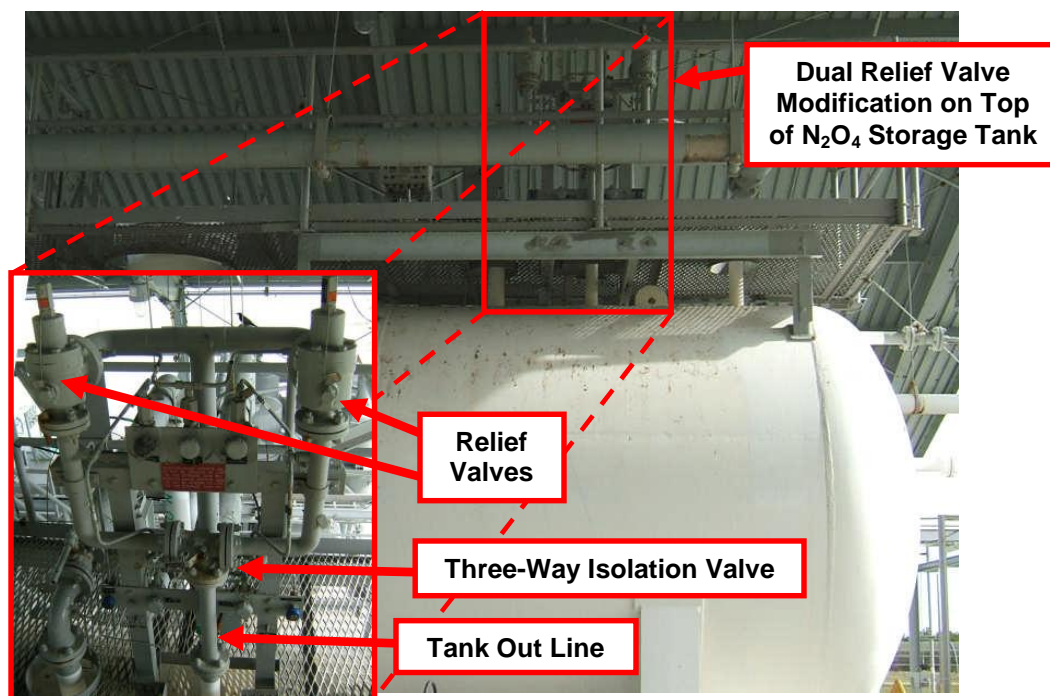
Figure 21-1: Dual Relief Valve Modification Location

An improper GSE design and operational human error were the root causes of this incident. About ten months prior to this relief valve removal and replacement operation, a formal request had been submitted by engineering to install a dual relief valve system onto the storage tank with a three-way isolation valve to prevent a vapor release during component removal. This request was denied. Following the large vapor release, the modification was implemented at both launch pads, greatly reducing the possibility of any future hazard. This dual relief valve modification allowed for isolation during the relief valve annual maintenance. The modification was also implemented on the fuel storage tanks at both launch pads. Figure 21-1 is a photograph of the relief valve locations on the top of the N_2O_4 storage tank with a close-up photograph of the relief valve three-way isolation valve modification.

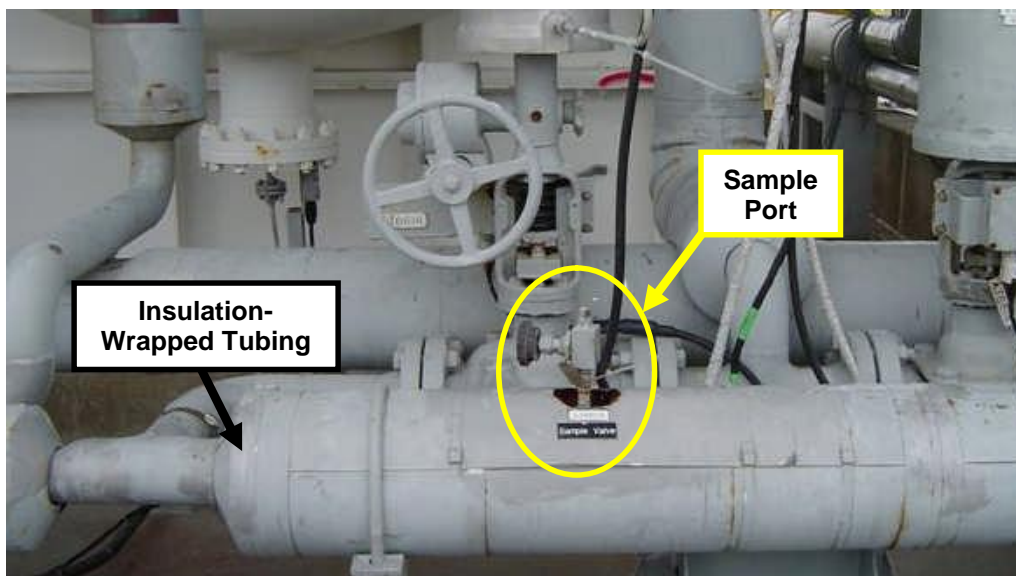
Figure 23-1: Photograph of Sample Port

On May 25, 1988, at the Pad 39B oxidizer farm, technicians were completing an N₂O₄ sampling operation. During the operation, the technicians detected a small leak at the interface between the sampling valve and the tubing (see Figure 23-1). The sampling operation was delayed until the leak could be fixed. The repair was finally scheduled to be worked about a month later during the afternoon of June 23, 1988. The removal of some local insulation was required to fix the leak along with re-torquing the fitting that connected the sample valve to the tubing. This was all completed that afternoon.

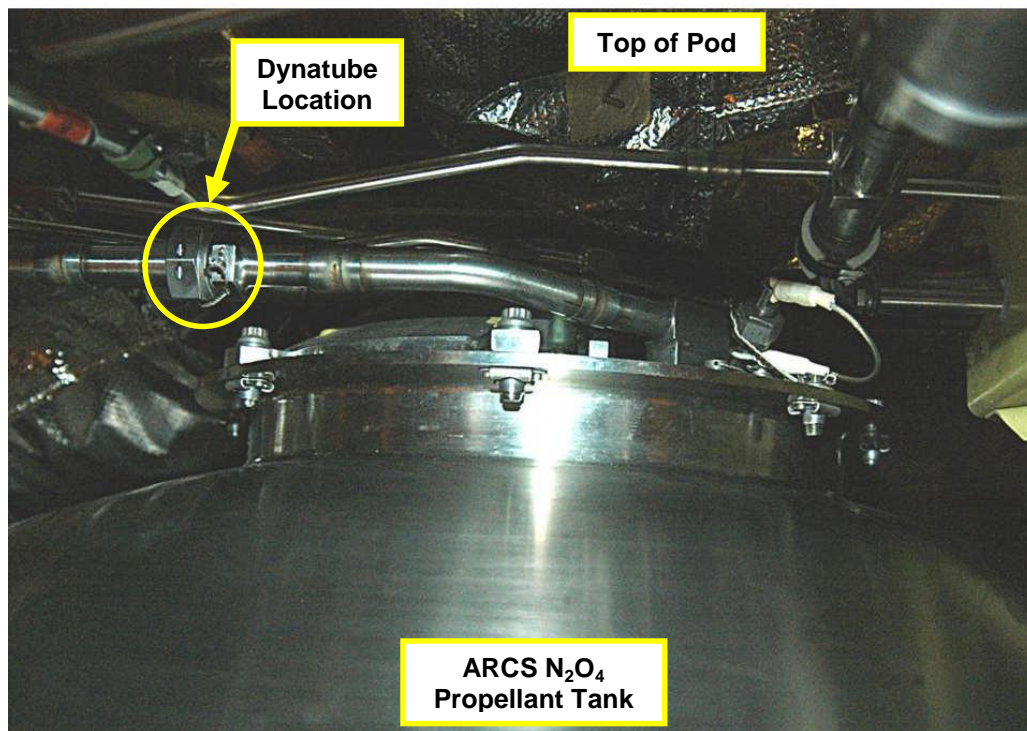
Figure 24-3: Dynatube Location on ARCS N₂O₄ Tank

First, the exact location of the leak within the pod had to be found (a cutaway view of the Space Shuttle OMS pod can be seen in Figure 24-1). This was difficult because the internals of the aft pods and forward module are not meant to be accessed while the vehicle is at the launch pad. The location of the leak had been isolated to the LRCS N_2O_4 system or the associated tubing through monitoring of the instrumentation in the LCC. The leak was measured to be 0.26 psi per hour (about 800 standard cubic centimeters per hour) and a TVC found the concentration of NO_2 vapor to be 15 ppm at the vehicle vent door. This later decreased to 3 ppm. An access door was removed on the pod's outer skin and several internal thermal blankets were removed. A long section of PVC pipe was then inserted into the pod to function as a guide for a borescope. Using a borescope, the leak was finally isolated (after a six hour search) to a ½-inch dynatube fitting on the MD224 leg (the N_2O_4 propellant tank ullage vent). A cross-section view of a dynatube is shown in Figure 24-2 and a photograph of the leak location can be seen in Figure 24-3.

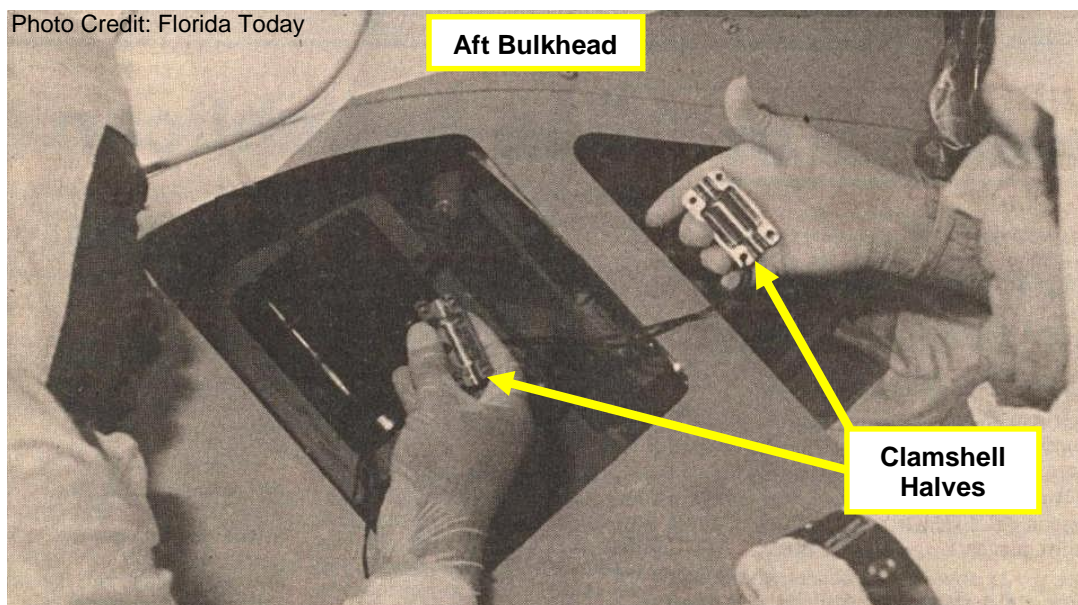
Figure 24-5: Technicians Repairing STS-26R Leak at the 1307 Bulkhead

After a week of deliberation, the “clamshell” was selected as it was the least invasive method to stop the leak prior to launch and it could be completed at the launch pad. Furmanite FSC-6B was used as the sealing compound as a result of it having the best compatibility characteristics with N_2O_4 . The FRF was finally completed on August 10, 1988 following a few hardware-related delays. The repair of the oxidizer vapor leak began on August 17, 1988 with the cutting of two holes in the aft 1307 bulkhead (the bottom of the payload bay with the orbiter in the vertical orientation) and the top of the pod beneath the bulkhead. The dynatube’s safety wire was removed and a “clamshell” (shown in Figure 24-5) was placed over the leak. The Furmanite sealing compound was then injected. The leak was eliminated; therefore, the Space Shuttle Program cleared Discovery for launch, which successfully occurred on September 29, 1988, a few weeks later than the original launch date of September 6, 1988. The delay was a result of multiple items including the FRF test delays, return to flight SRB testing delays in Utah, and the N_2O_4 leak on LP04.

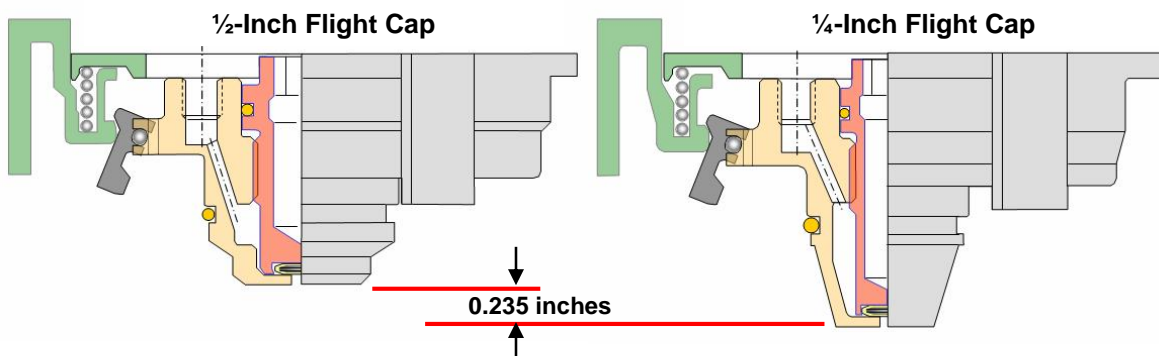
Figure 29-1: ¼-inch and ½-inch Hypergolic Flight Cap Cutaway View

- The appearance of a ¼-inch AHC cap is such that it could be mistaken for a ½-inch AHC cap to an untrained technician
 - The technician was undergoing on the job training under the direct supervision of an experienced technician, but the distinction between a ¼-inch cap and a ½-inch cap was not explained to him
- Age and wear made part number identification on the AHC cap difficult
- Work instructions should be written to include positive identification of interface equipment
- AHC cap mating should not be considered a benign activity; therefore, PPE should be used to protect the employees from credible releases of propellants
- Future designs should consider keying of AHC caps to preclude incorrect size/commodity installation

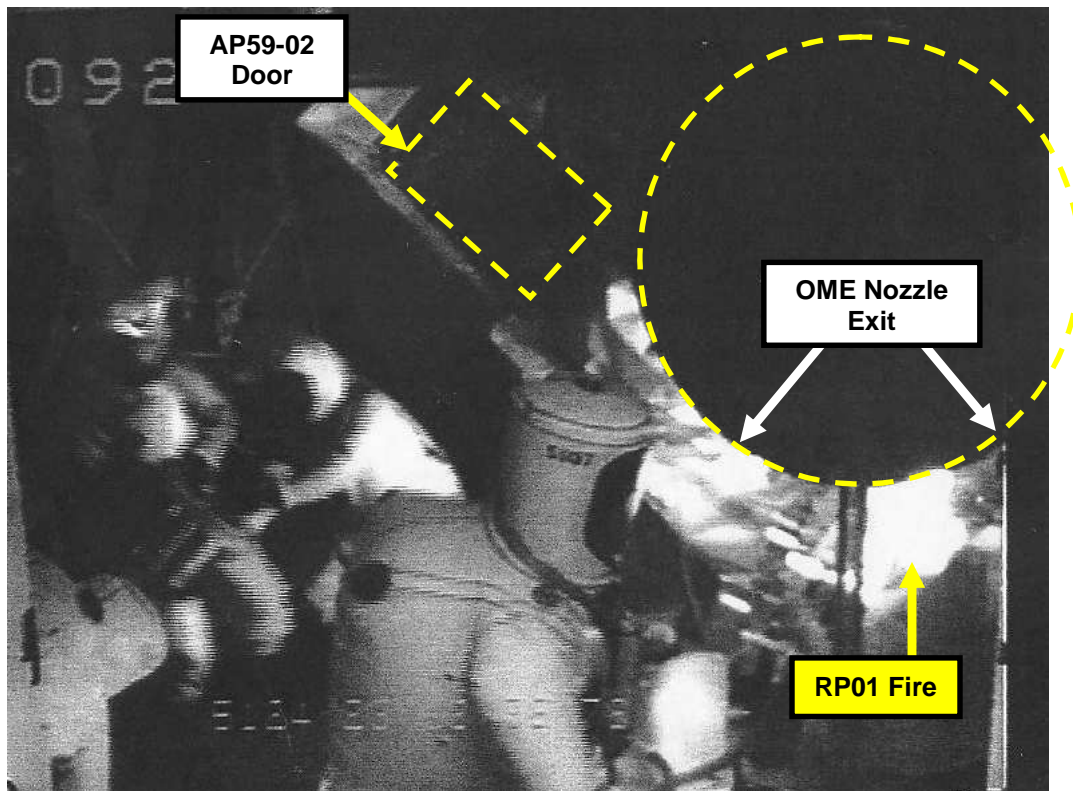
Figure 33-1: Still Photograph from Video of RP01 Fire

During the STS-69 OV-105 flow, while performing a thruster R1A removal and replacement, a fire broke out in the Space Shuttle right OMS pod stinger area. The fire burned strongly for about 30 seconds and a smaller flame burned for about one minute and 45 seconds. The size of the flame was estimated to be approximately 15 inches x 11 inches x 11 inches with a damage region of approximately 22 inches x 14 inches x 14 inches in the stinger. The materials that burned included several ounces of fuel, a shop light, and the Orcofilm spill protection (flame retardant covering films). Figure 32-1 is a still image from the video recording during the fire and Figure 33-2 is a clearer color photograph of the same area for reference.

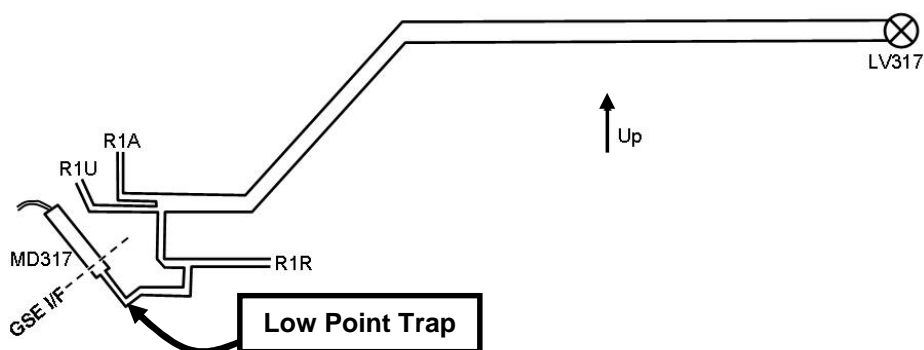
Figure 33-3: Approximate Manifold 1 Layout Schematic

Another possible scenario (not included in the formal mishap report) for the pressure increase was put forth stating the pulse purges were unable to remove all the liquid MMH as a result of a low point trap present in the manifold near the MD317 (manifold 1 drain/purge QD) AHC interface. Figure 33-3 shows the basic layout and low point in fuel manifold 1 in the right pod stinger area. It is believed that during the purge, gas was unable to enter the line through the MD317 QD to displace the liquid MMH out of the manifold. This was a result of a small bubble that had formed in the low point as a result of helium coming out of the liquid MMH/helium solution. The helium slowly coming out of solution may have been the source of the pressure rise in the manifold rather than a leaking manifold isolation valve. Once the fire started, it heated the area thus increasing the pressure and pushing additional fuel out of the fuel feedline that was trapped. In both scenarios (leaking manifold isolation valve or helium coming out of solution), liquid MMH was present in the manifold line just prior to and during the fire and the manifold pressure increase went unnoticed.

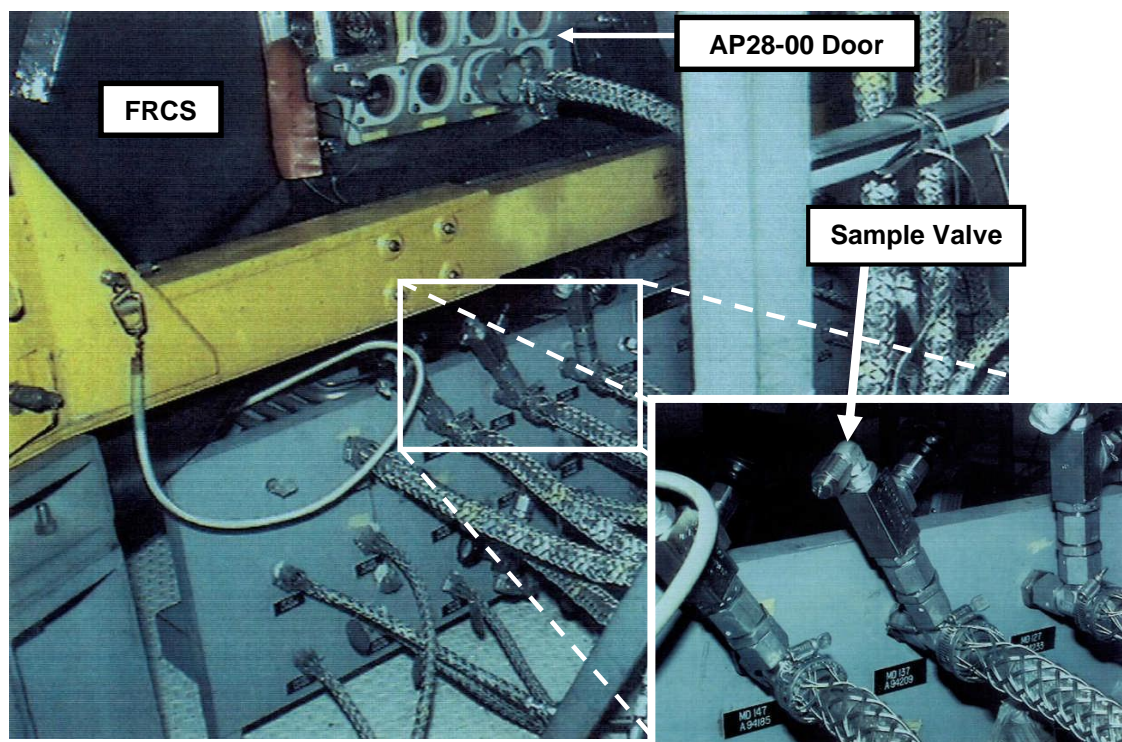
Figure 36-1: MD137 Flexhose Sample Valve

One technician powered up the aspirator and then began to remove the sampling valve outlet cap from the MD137 flexhose (see Figure 36-1 for a close-up view of the sampling valve). A TVC of the area was then performed with a resulting reading of 0.0 ppm. The technician laid the aspirator hose on the side of the rack, which was not a suitable position to capture any liquid or vapor that may be released from the valve outlet as the procedure stated.

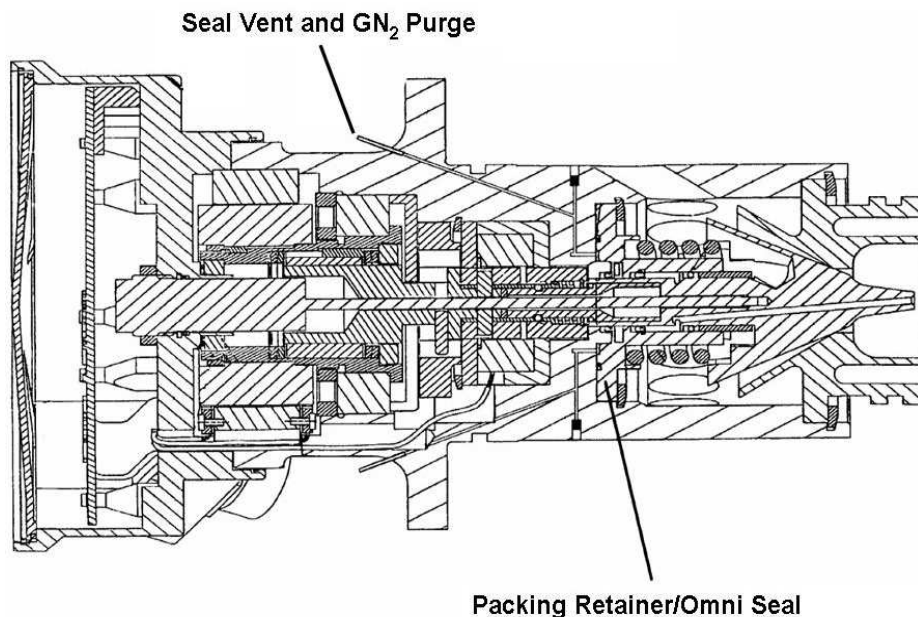
Figure 37-2: Titan IV A TVC FCV Cutaway View

The source of the leak was found to be the electronic compartment purge ports on two flow control valves (FCVs) on SRM #1 and one FCV on SRM #2. A cutaway view of the FCV is shown in Figure 37-2. These valves (along with the one remaining valve that did not leak) were removed and sent to the manufacturer for failure analysis. Upon disassembly of the three failed valves, evidence of combustion was noted at the electrical compartment's omniseal. The omniseal had been extruded through the sealing surface and the retainer ring had been ejected. The degradation of the omniseal resulted in liquid N_2O_4 flowing into the FCV's electronics compartment and out the purge port. There were no leaks found within the TVC propellant tank or the associated system plumbing.

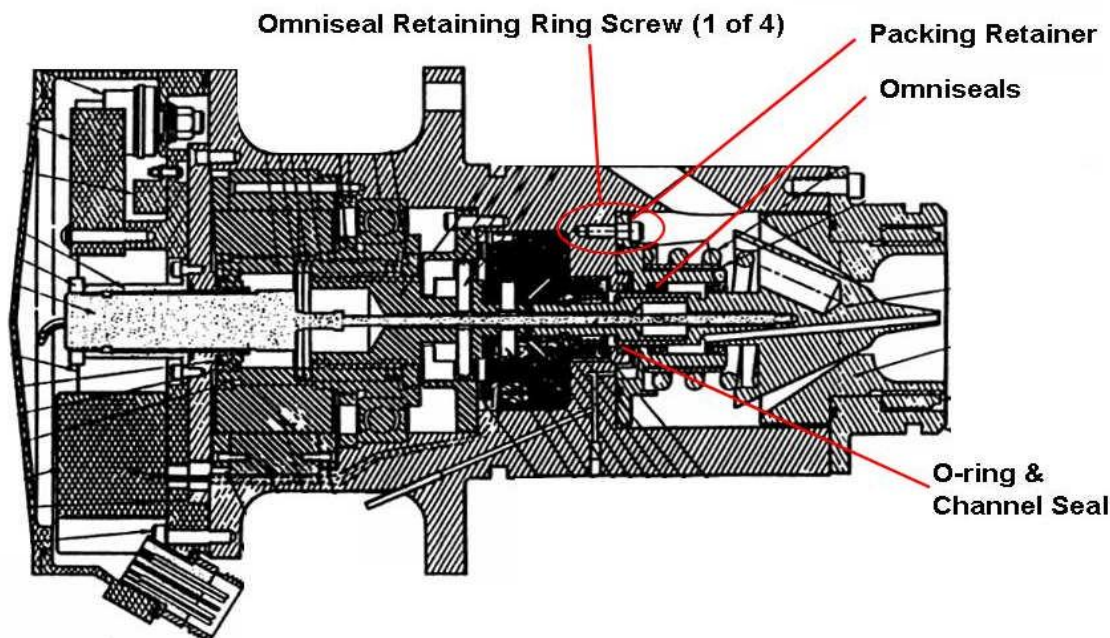
Figure 37-3: Titan IV A TVC EMV Cutaway View

The component design change was driven by the difficulty in manufacturing the EMVs, as well as some of its internal components becoming obsolete. A cutaway view of the EMV is shown in Figure 37-3. The intent of the valve redesign was to make as few changes as possible to allow for consistent manufacturing, part machining, and part procurement, as well as using the same outer housing of the valve to allow the new FCV to essentially be "dropped in" without any TVC system modifications. There are several noted differences between the two valve designs. One significant difference is their method of fastening the packing retainer to the omniseals. Both designs utilize an omniseal to isolate the N_2O_4 from the valve's electronic compartment. However, the original EMV design fastened the omniseal and packing retainer using four screws, whereas the superseding FCV design employed a snap-ring to fasten the retainer. The four mechanical screws on the EMVs left a much smaller gap (if any) between the component surfaces, whereas the FCVs snap ring design, while sufficient for its launch duty, had a large enough gap between the component surfaces that the liquid Bio T-200A cleaning solvent was able to accumulate on the omniseal spring.

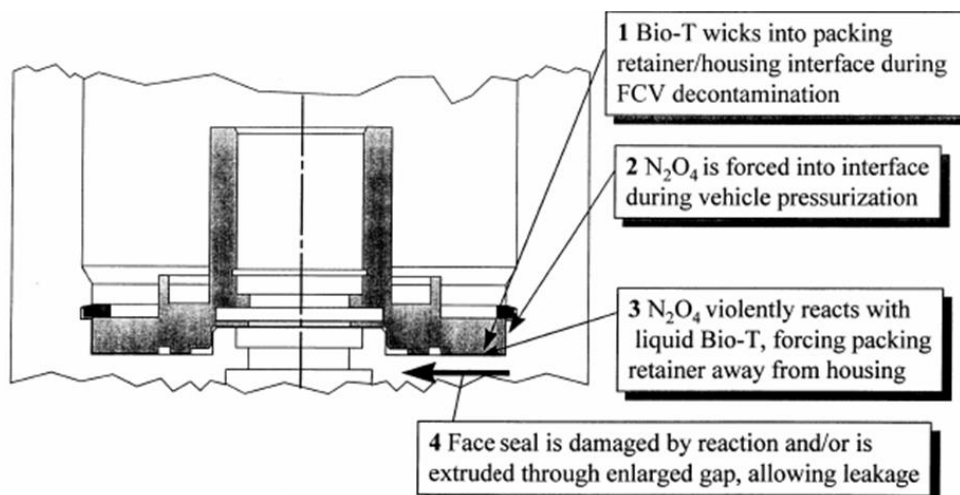
Figure 37-4: Titan IV A FCV Failure Description

1. By the completion of the TVC N_2O_4 propellant tank loading, the cavity adjacent to the packing retainer filled with liquid N_2O_4
2. The liquid N_2O_4 vaporized and migrated into the packing retainer crevice
3. During the tanks' pressurization, the trapped N_2O_4 vapor re-condensed into a liquid and reacted with the residual Bio T-200A in the packing retainer crevice (see Figure 37-4)
 - The energy of this reaction damaged the packing seal
 - The force of the increased system pressure overcame the remaining, compromised integrity of the seal components and thus flowed past the seals to atmosphere.
